EARLY ACTION AT THE LOWER DUWAMISH WATERWAY

OCTOBER 6, 2022 | PRESENTED BY: KATIE PAGE

Lower Duwamish Waterway Superfund Site

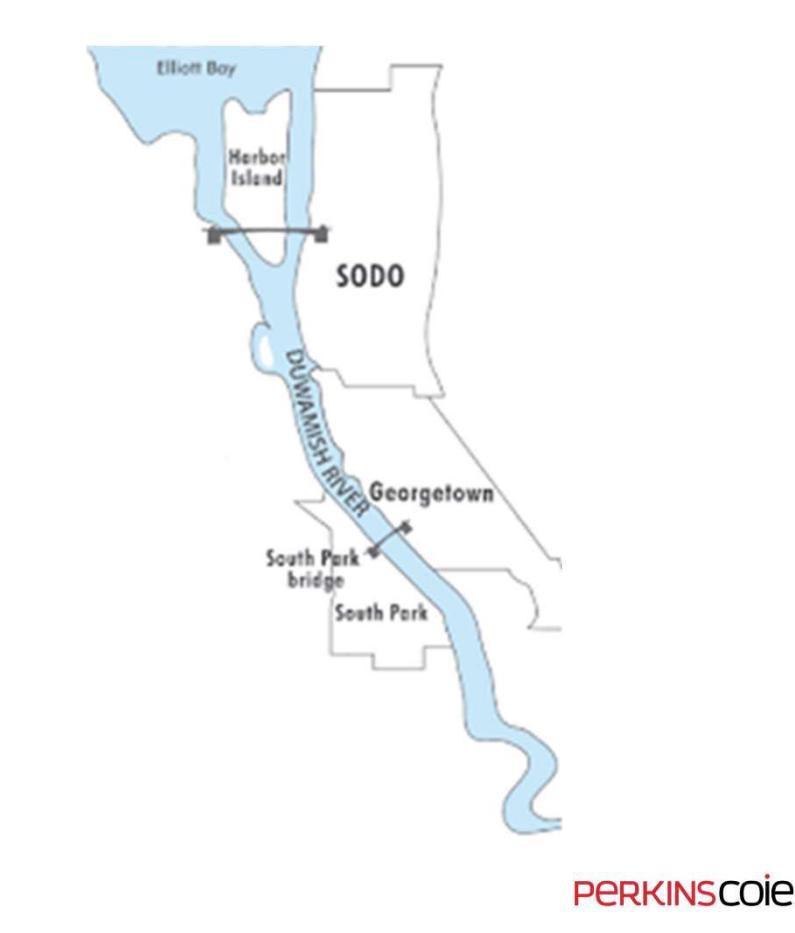
- 5-mile stretch of waterway in Seattle
- Seattle's major industrial corridor since the early 1900s
- Legacy contamination from industrial discharges, CSOs, storm drains, etc.
- 43 contaminants of concern, including PCBs, arsenic, cPAHs, and dioxins/furans

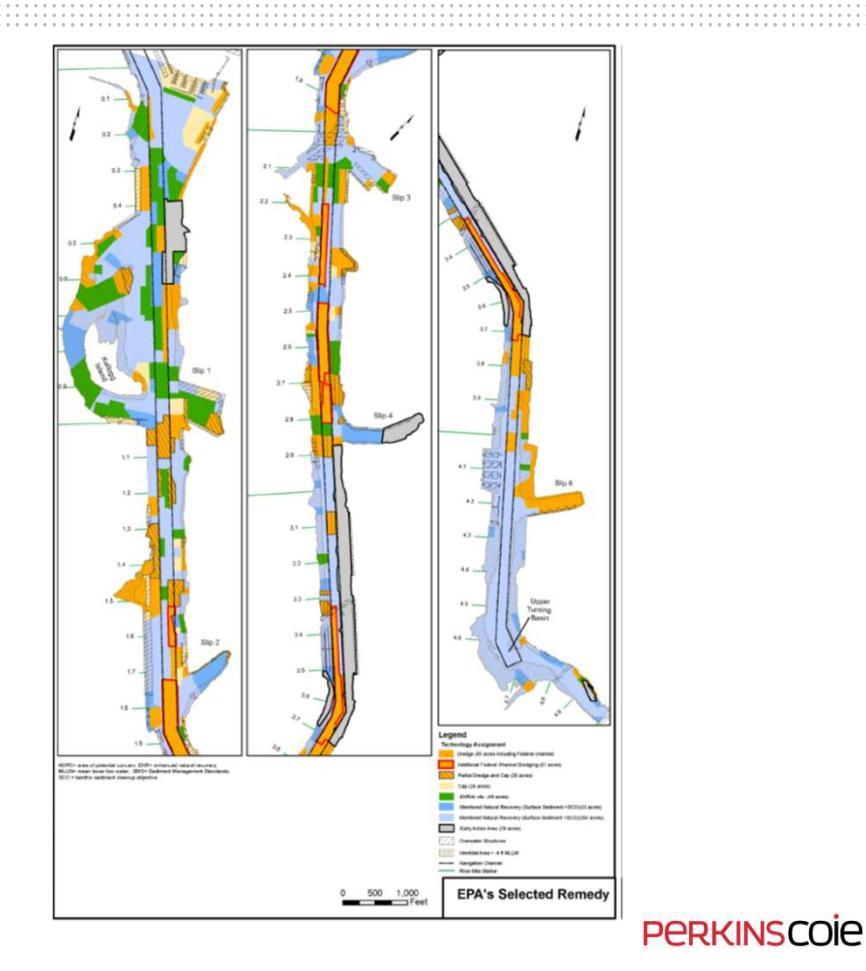
- Selected remedy for in-waterway portion of LDW Site
- Patchwork of remedial technologies
- Estimated 960,000 cubic yards to be dredged
- 412 acres total
- 177 acres of active cleanup
- Remedy construction to begin after:
 - Upland sources controlled
 - Remedy design work
 - Early cleanups completed

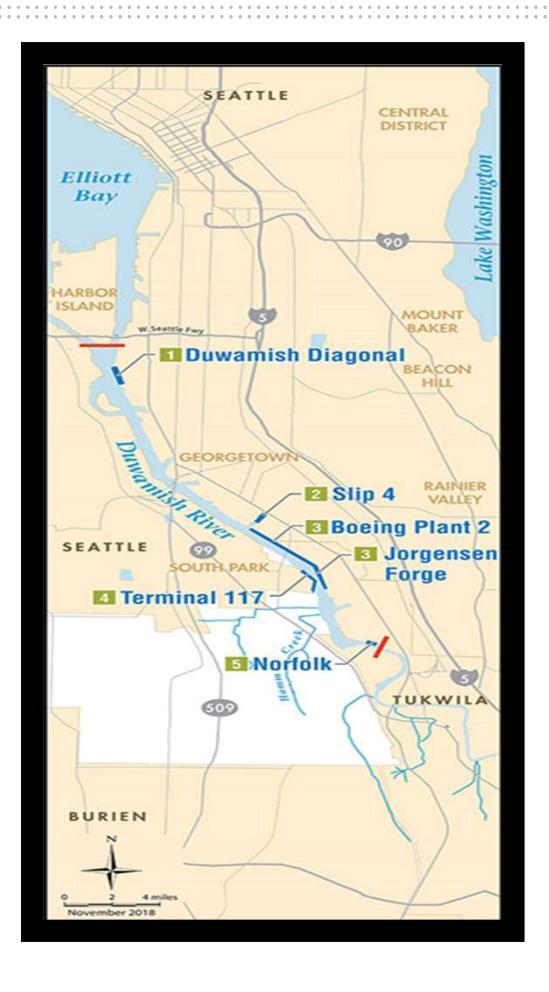
- As part of the RI, LDWG identified 7 potential areas for early cleanup
- 5 of those were selected for early cleanup
 - Norfolk
 - Duwamish Diagonal
 - Slip 4
 - Terminal 117
 - Boeing Plant 2

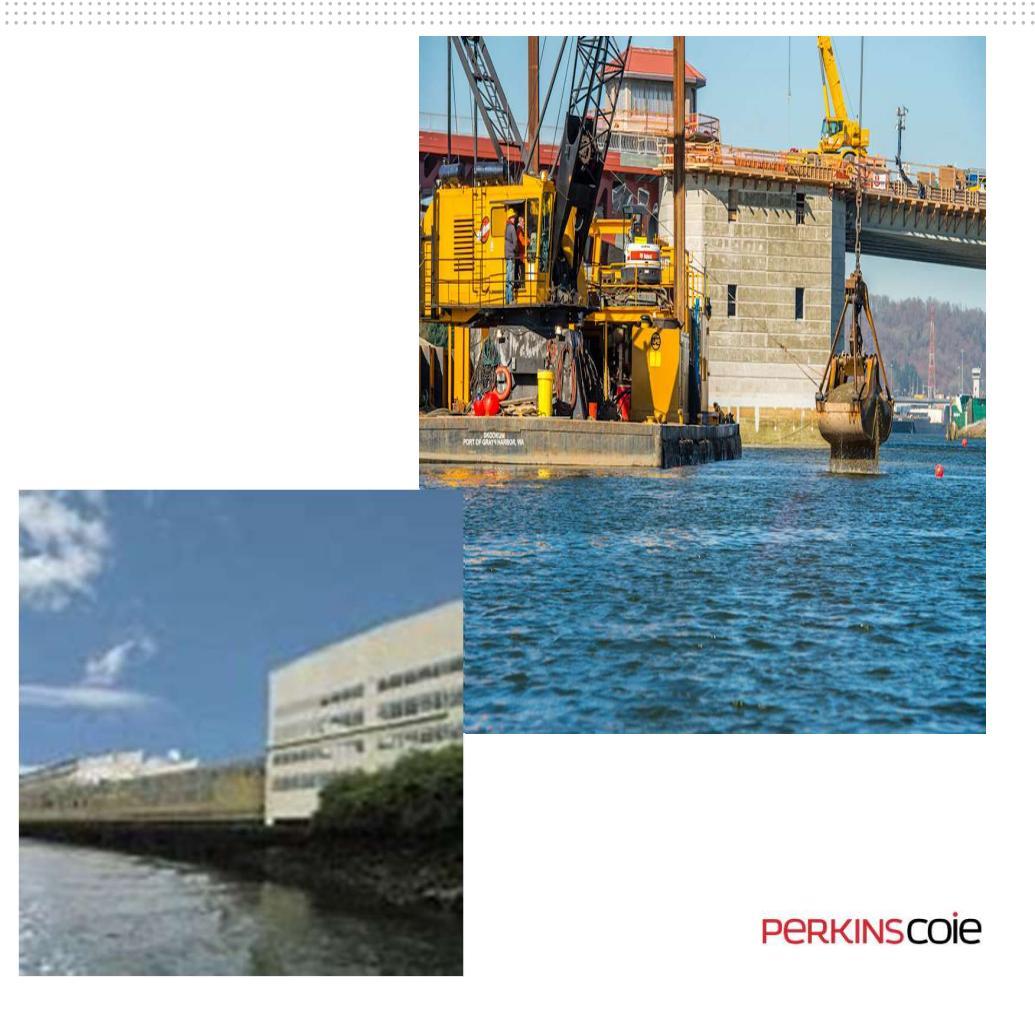
- Cleanup completed in 2015
- Three years of dredging
- 18.3 acres
- 163,000 cubic yards of sediment removed
- Also removed:
 - Bank soils
 - Over-water buildings
 - Hundreds of creosote-treated pilings

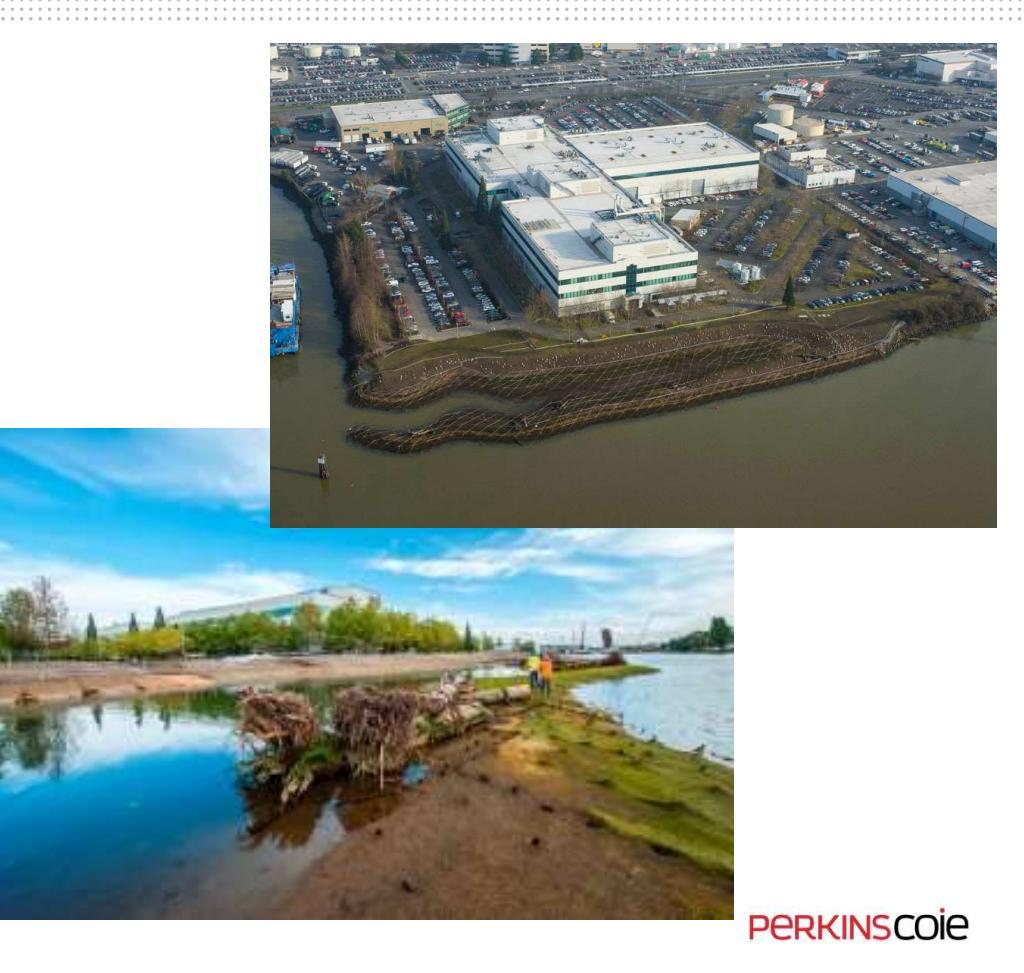
- Conversion of 1 mile of hardened shoreline at Plant 2
- Five acres of shoreline habitat for fish, birds, etc.
 - Off-channel habitat
 - Intertidal wetlands
 - 170,000 native plants
